# Environmental Consultancy

## The Project

Geo-Environmental were appointed to document the events leading up to an oil spill incident and provide advice on the subsequent clean-up operations at a former horticultural nursery site.

## Background to the Incident

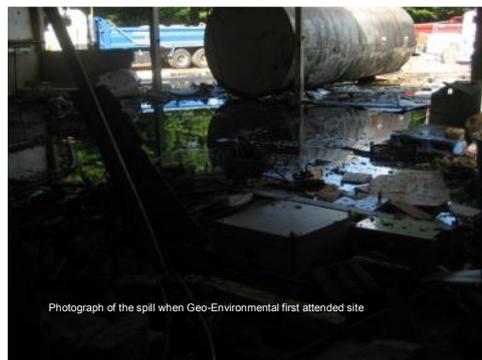
It is understood that a contractor was appointed to remove a heating system for the derelict horticultural nurseries. The heating system comprised a large un-banded heating oil tank partially filled with waste automotive oil, two boilers and a network of pipes (some running in culverts) to distribute heat throughout the glasshouses. The tank was within a commercial barn structure and was estimated to have a capacity of approximately 15,000 litres. It is unclear how much oil was contained within the tank at the time of the spill.

It was evident that contrary to the approved Method Statement, an attempt was made to move the tank without first removing the oil and making the tank safe for removal. Instead the brick cradle supporting the tank was broken out and some attempt was made to move the tank whilst still containing oil.

This was in contravention of the safe methods of removal that had been agreed with the contractor. In moving the tank the pipework leading from the tank ruptured leading to a spill. The client was first aware of the spill when a member of staff

- Mobilise a cleansing tanker to site as soon as possible to suck up the oil sitting on the concrete floor slab and oil remaining in the tank.
- Obtain absorbent pads and granules to mop-up remaining oil and deploy booms around the perimeter of the building to prevent further migration of the oil.
- Mobilise an excavator and covered skip to site as soon as possible to dig out the limited areas of contaminated soft ground before significant migration could occur.
- Immediately cover the limited areas of soft ground with plastic until to protect it from forecast rain.

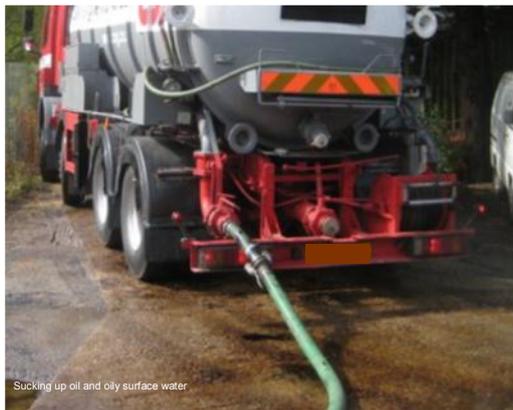
The remediation of the oil spill was supervised and documented by Geo-Environmental whilst the site work was undertaken by Demolition and Salvage Ltd. Within 24 hours the majority of the oil spill had been cleaned up, however the clean-up operation continued for a further two weeks.

- Cleansing Tanker to suck up oil and oily water
- Absorbent booms to limit spread of oil spill
- Absorbent pads to absorb oil spill
- Imported soil to replace contaminated soil
- Removal of shed floor slab
- Remove of contaminated soft ground
- Cleaning of storm water drain system
