# Housing Development

## The Project

# Stormwater Management

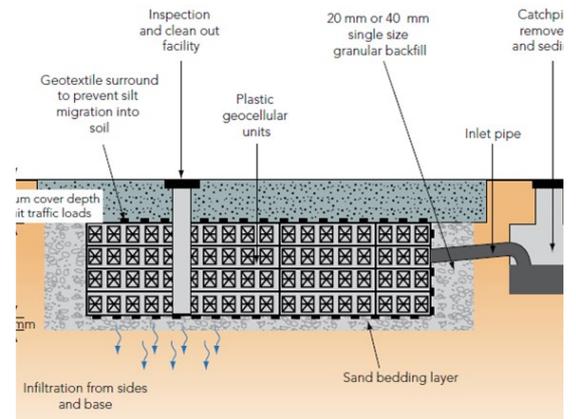
Figure 2 - Attenuation Crates

4. Our report provided the client with a fully sized and costed SuDS system for handling storm water and a system for handling the foul water, as well as detailing where those systems would be situated on the site.
